CARPET STORE FIRE

Branford, CT

November 28, 1996

**Carpet Store Fire
One Fire Fighter Fatality
Branford, CT
November 28, 1996**

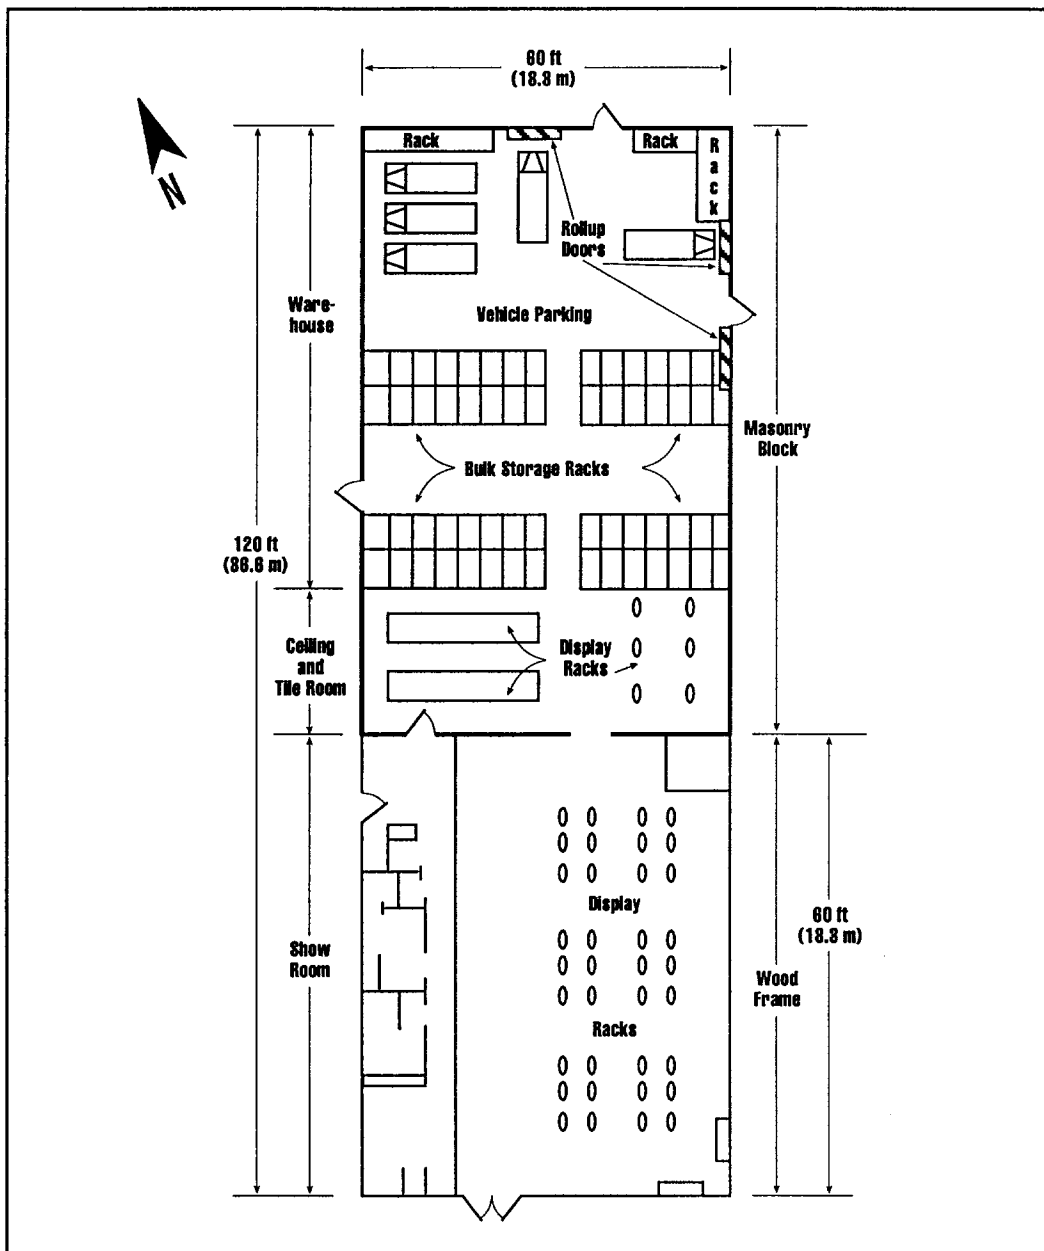
Figure 1: Plan view showing carpet store

The carpet store was in a 7,200-sq ft (669-sq m) building that contained showroom areas, offices, and a warehouse area. (See Figure 1.) Each area had at least one exit providing direct access to the exterior of the building. Both the office area and the warehouse supported the facility's primary function, namely, the retail sale of carpet and tile products. Since the facility was primarily a store, the Branford carpet store will be considered a Class B Mercantile Occupancy according to the 1994 edition of *NFPA 101®*, *Life Safety Code®*.^{1,2}

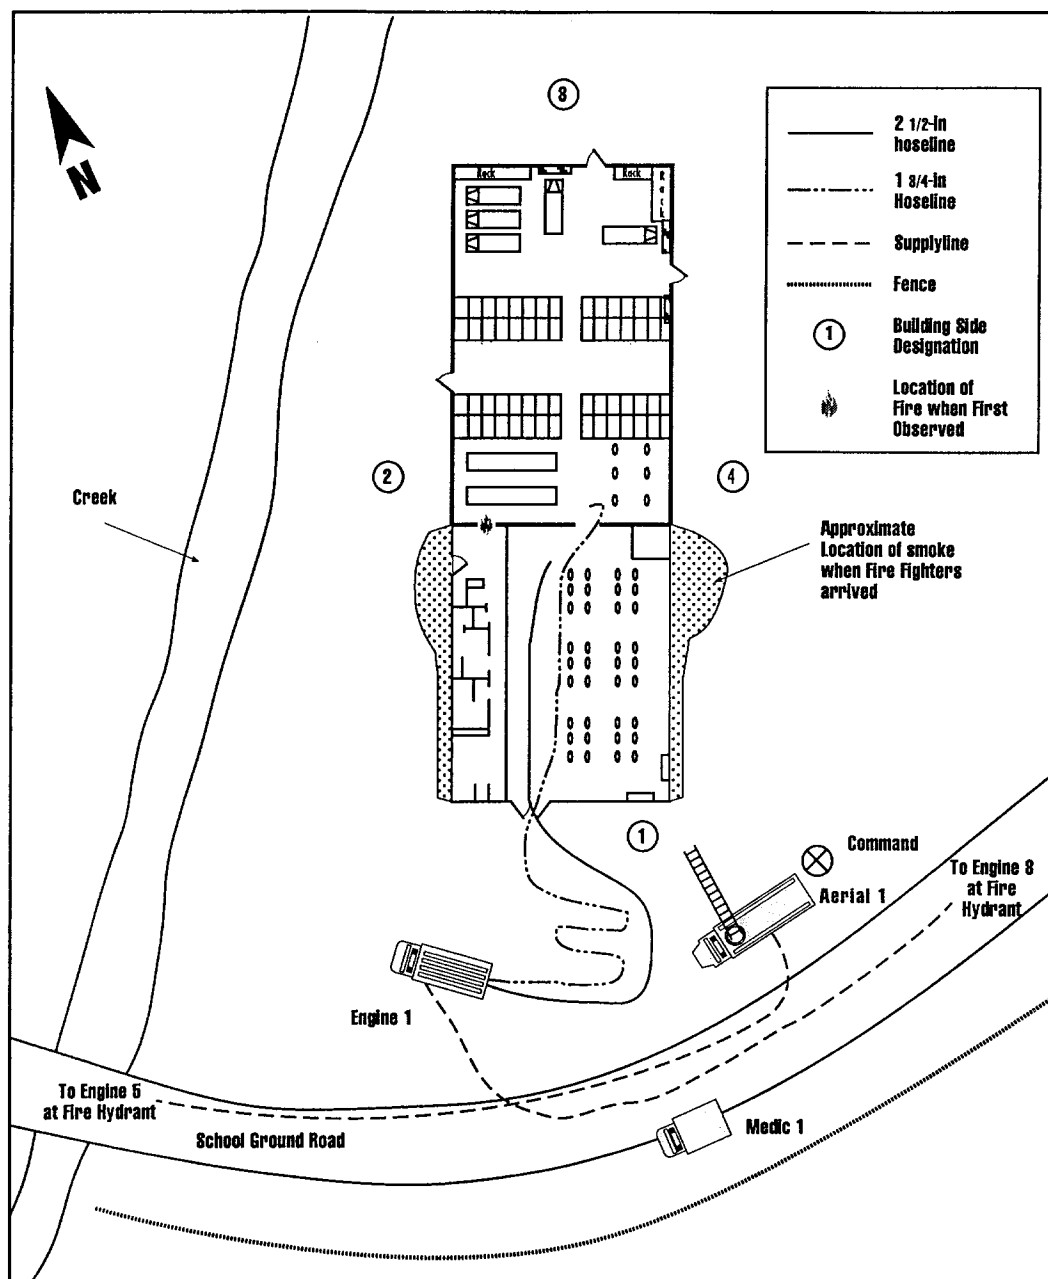
Figure 2: Fireground operation

The incident commander left Engine 1 and proceeded up to the fire building to begin his initial size-up while the supply line was being removed from the engine. As this officer approached Side 1 and Side 4 corner of the building, he found light brownish-gray smoke showing near the roof eaves and coming from soffit vents.⁵ (See Figure 2.) The smoke appeared to be coming from the wood-frame section of the building, and the smoke was heaviest in the back of this section near where the construction changed to masonry block.

The incident commander continued his initial size-up and went around to Side 2. He found the same light brownish-gray smoke coming from eave vents as he had seen on Side 4. Since the smoke was not pushing or billowing out of the building under pressure, the incident commander believed that the fire must be relatively small and in the front part of the building.

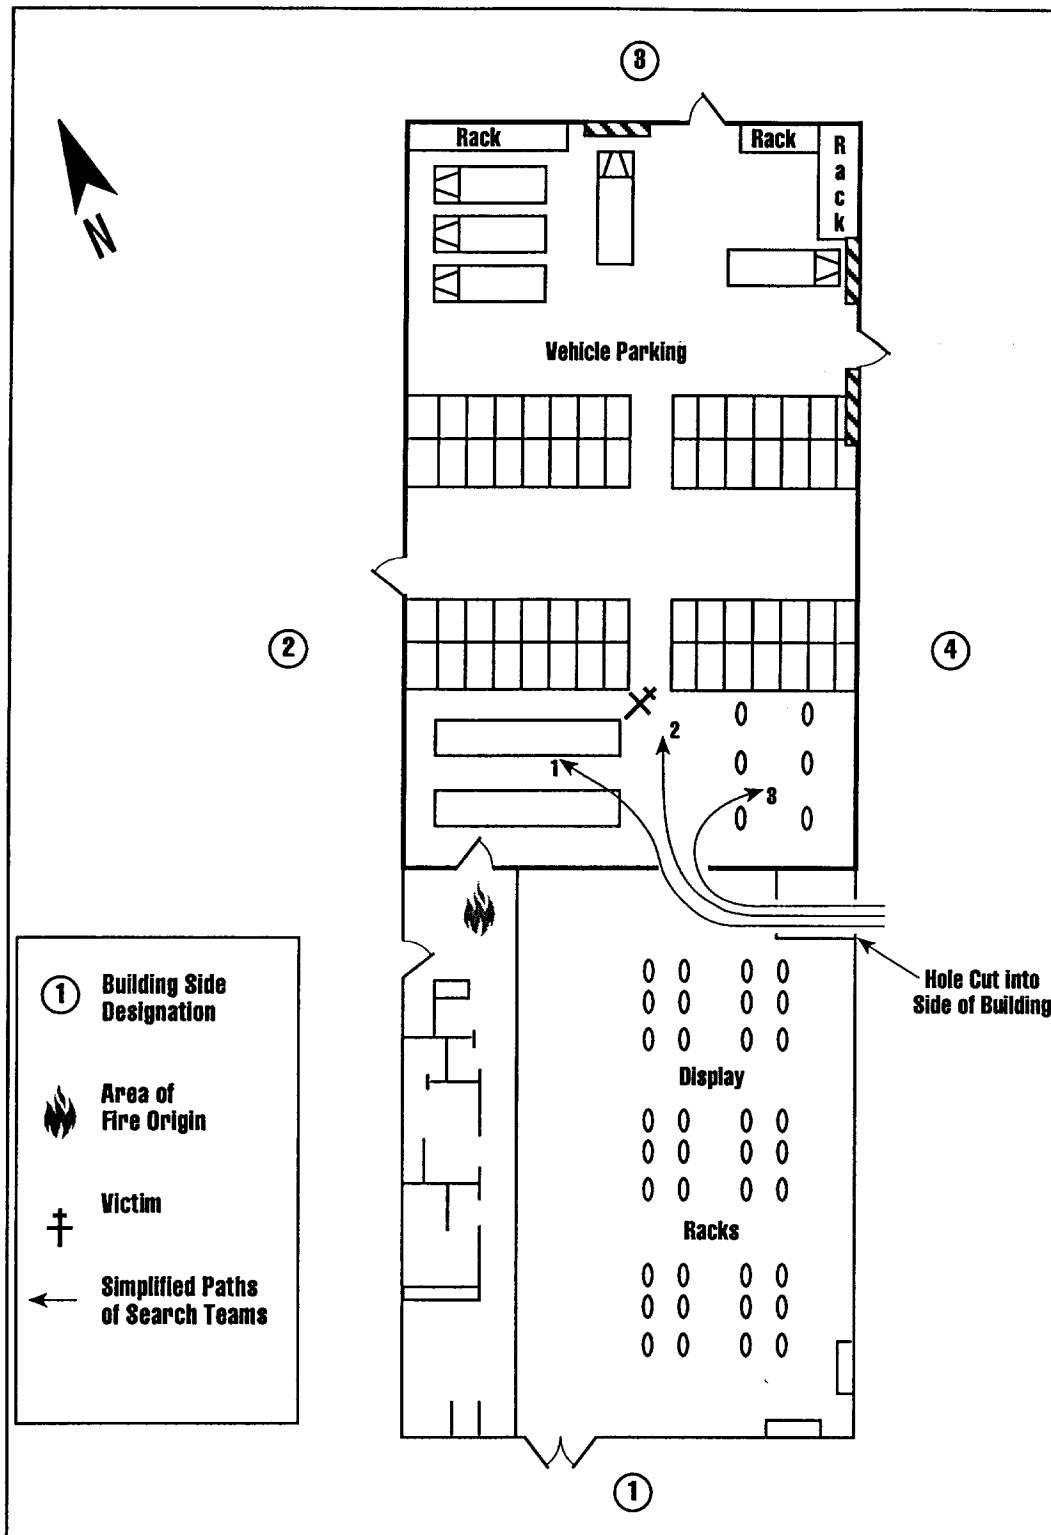
Figure 4: Rescue operation

The new incident commander consulted with other senior fire officers and developed a plan to get fire fighters into the building and to systematically search for the missing fire fighter. The officers decided to cut a hole in the wood-frame wall near the northeast corner of the carpet showroom even though they believed the missing fire fighter was in the part of the building that had masonry block walls. (*See Figure 4.*) Some of the officers recognized that the masonry block wall was beginning to appear unstable and felt that a breach of the wood-framed wall would pose less risk to the fire fighters who would be entering the building.

Once the ladder pipe controlled most of the severe fire in the center of the building, three search teams, with six fire fighters in each team, entered the building with hoselines. They moved slowly, extinguishing the fire as they advanced into the building. The crews working in the building were relieved several times by new crews. The missing fire fighter was found at approximately 7:30 p.m., three hours after the initial dispatch of fire crews. Once the victim was located, all Branford fire fighters were withdrawn from the building. The victim was pronounced dead at 8:00 p.m. by a medical doctor who was also a Branford fire fighter. The victim was removed from the building by fire fighters from other towns. These fire fighters had come to the scene and had offered their assistance.
